**Re: ATCO Pipelines  
Radiographic Weld Inspection**

**ATCO-AUC-2016MAY13-001 (REVISION)**

**ATCO-AUC-2016JUN27-001**

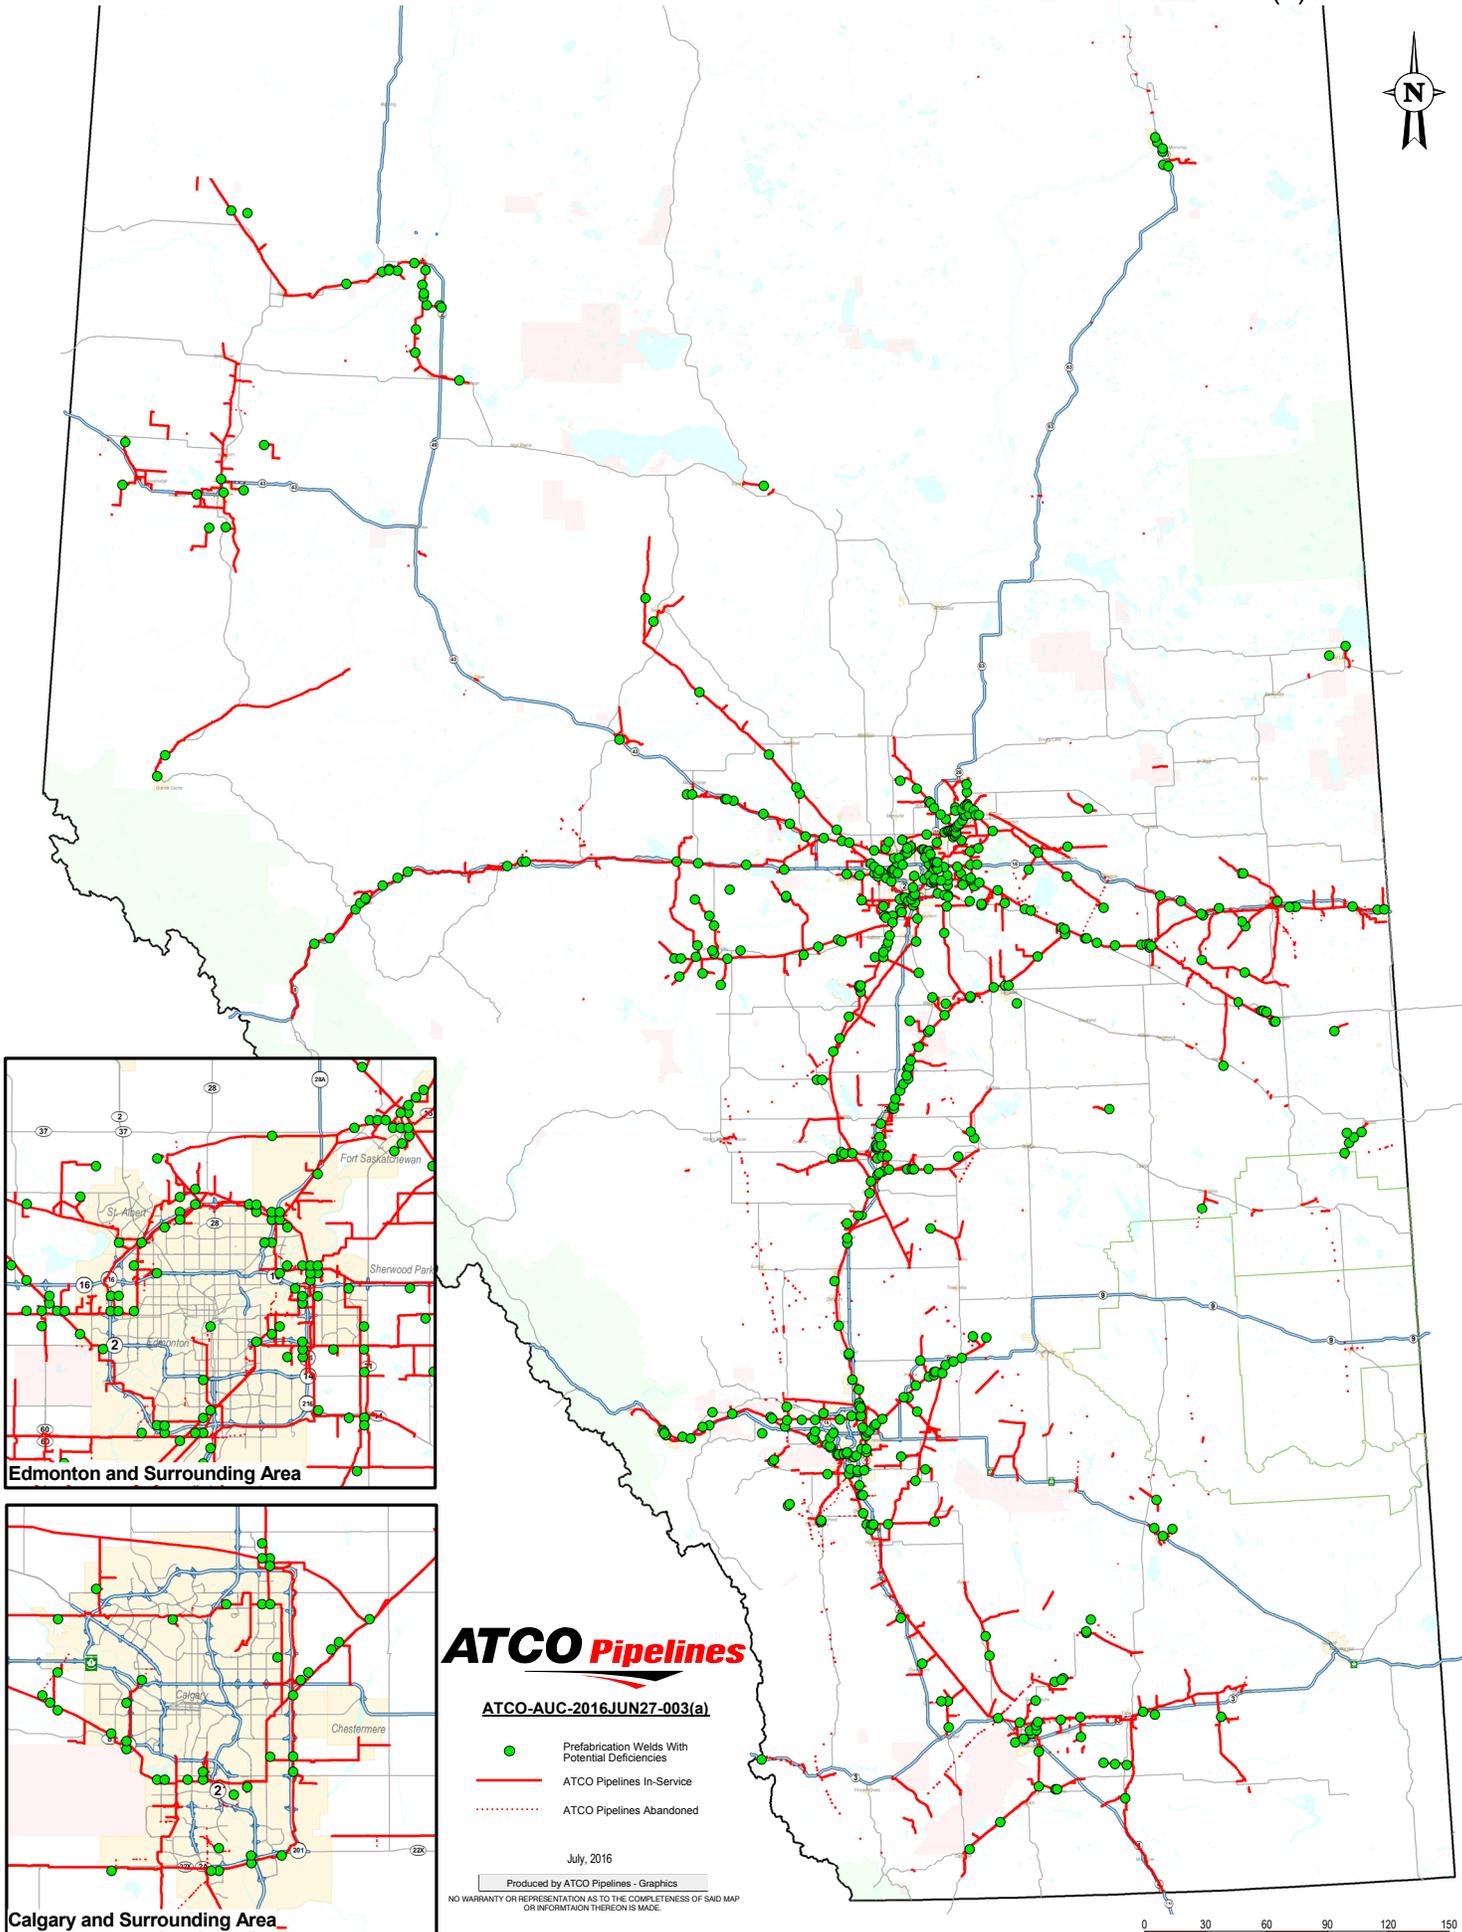
ATCO-AUC-2016JUN27-003(a)

- Prefabrication Welds With Potential Deficiencies
- ATCO Pipelines In-Service
- - - ATCO Pipelines Abandoned

- (a) Please refer to ATCO-AUC-2016JUNE27-003(a) Attachment, which includes an ATCO system map indicating each of the 378 geographic locations having prefabrication welds with potential deficiencies.
